MOORING CONDITION REPORT

**NORFOLK NAVAL
SHIPYARD**

CR-6119-OCN

September, 1999

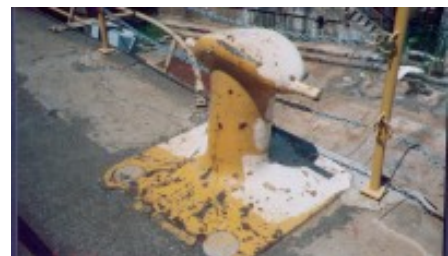
Photo 3.20-2, Dry Dock 4, fitting DD4S-B8, M bollard in good condition, # 1 rating.

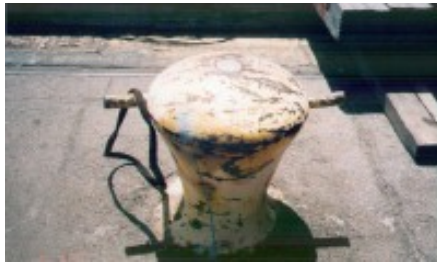
Photo 3.20-3, Dry Dock 4, fitting DD4S-B7, short bollard in good condition, # 1 rating.

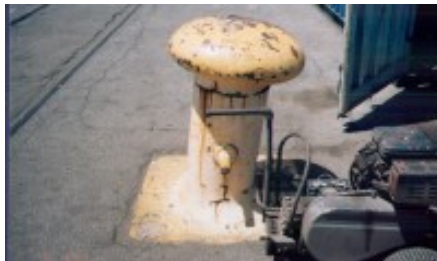
Photo 3.20-5, Dry Dock 4, fitting DD4S-B6, M bollard in good condition, # 1 rating.

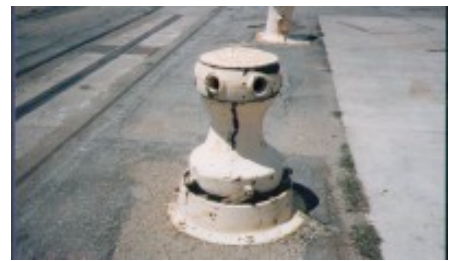
Photo 3.20-6, Dry Dock 4, fitting DD4S-CP2, windlass in good condition, # 2 rating.

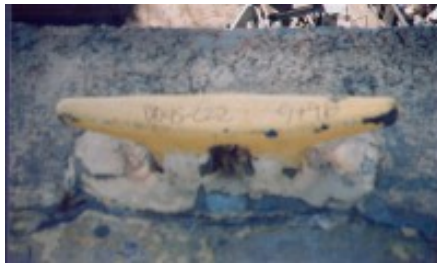
Photo 3.20-7, Dry Dock 4, fitting DD4S-C22, 26" cleat in good condition, # 1 rating.

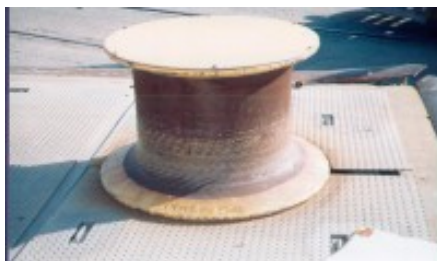
Photo 3.20-9, Dry Dock 4, fitting DD4S-CP3, capstan in good condition, # 1 rating.

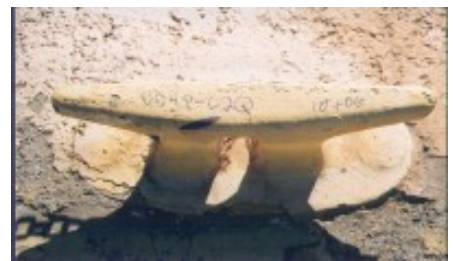
Photo 3.20-10, Dry Dock 4, fitting DD4P-C20, 26" cleat in good condition, # 1 rating.

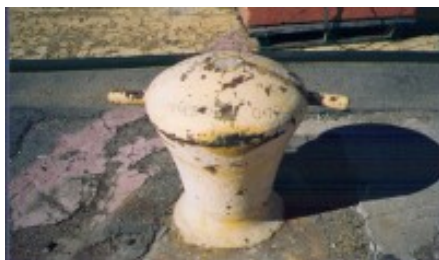
Photo 3.20-11, Dry Dock 4, fitting DD4P-B1, short bollard in good condition, # 1 rating.

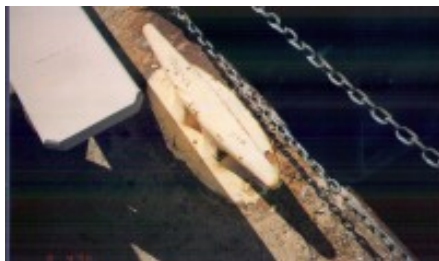
Photo 3.21-1, Dry Dock 6, fitting DD6S-C2, 26" cleat in good condition , #2 rating.

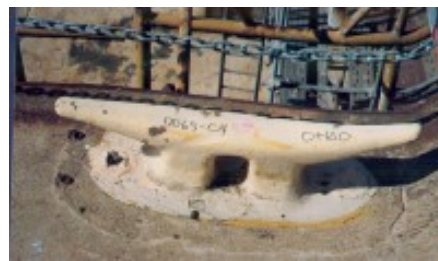
Photo 3.21-2, Dry Dock 6, fitting DD6S-C4, 26" cleat in good condition, # 1 rating.

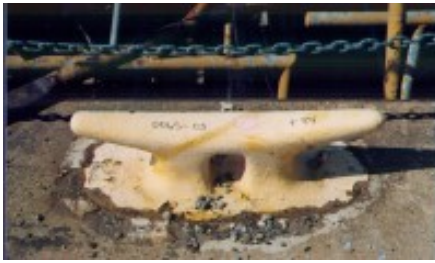
Photo 3.21-3, Dry Dock 6, fitting DD6S-C5, 26" cleat in good condition, # 1 rating.

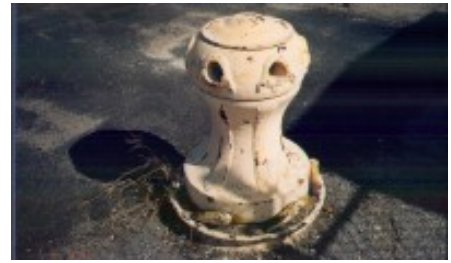
Photo 3.21-4, Dry Dock 6, fitting DD6S-CP1, windlass in good condition, # 1 rating.

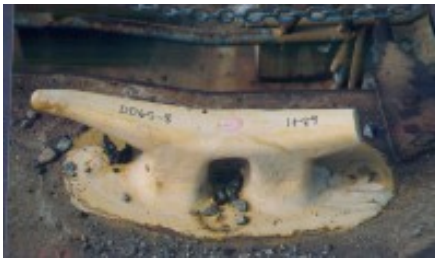
Photo 3.21-5, Dry Dock 6, fitting DD6S-C8, 26" cleat with broken horn, # 4 rating.

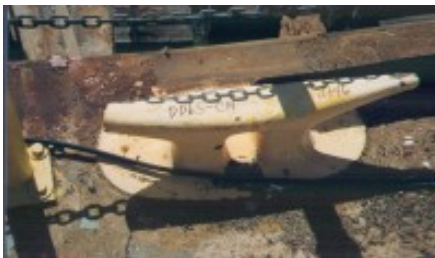
Photo 3.21-7, Dry Dock 6, fitting DD6S-C14, 26" cleat with broken horn, # 4 rating.

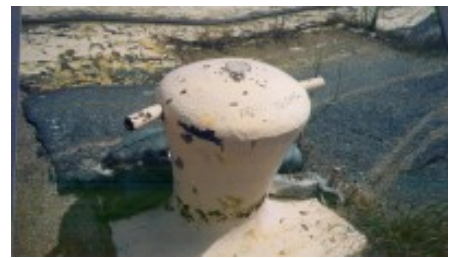
Photo 3.21-8, Dry Dock 6, fitting DD6/7-B2, short bollard with bent pin otherwise in good condition, # 1 rating.

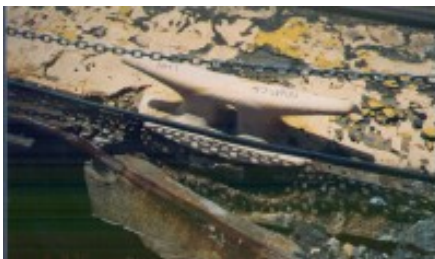
Photo 3.21-9, Dry Dock 6, fitting DD6P-C6, 26" cleat with base concrete disintegrated, #3 rating.

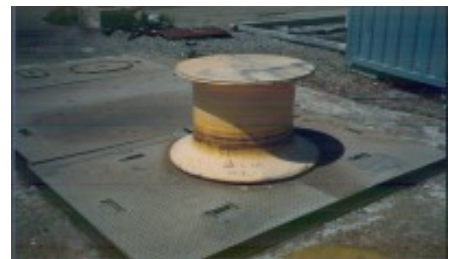
Photo 3.21-10, Dry Dock 7, fitting DD7S-CP1, capstan in good condition, #1 rating.

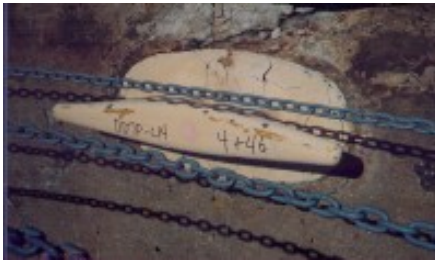
Photo 3.21-11, Dry Dock 7, fitting DD7P-C14, 26" cleat in good condition , minor cracking of concrete base, #2 rating.

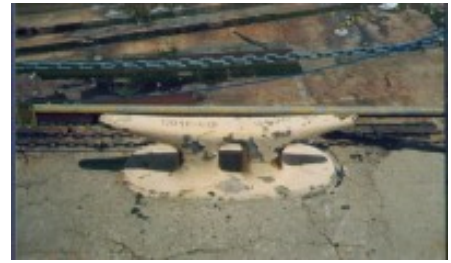
Photo 3.21-12, Dry Dock 7, fitting DD7P-C13, 26" cleat in good condition, # 1 rating.

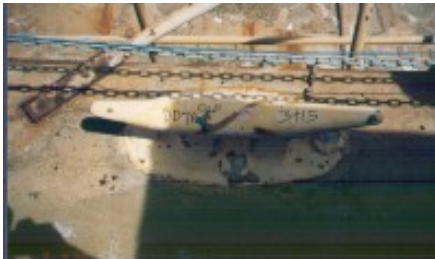
Photo 3.21-13, Dry Dock 7, fitting DD7P-C11, 26" cleat in good condition, # 1 rating.

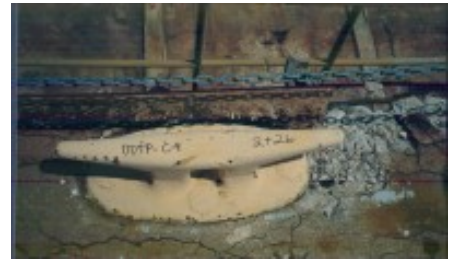
Photo 3.21-14, Dry Dock 7, fitting DD7P-C9, 26" cleat in good condition with minor cracking of concrete base, # 2 rating.

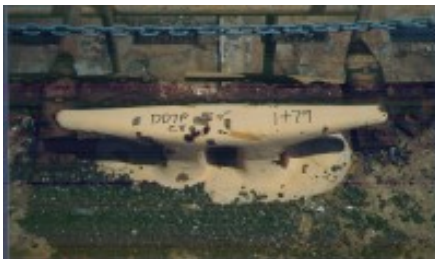
Photo 3.21-15, Dry Dock 7, fitting DD7P-C8, 26" cleat in good condition, #1 rating.

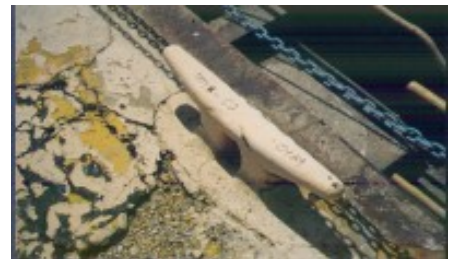
Photo 3.21-16, Dry Dock 7, fitting DD7S-C2, 26" cleat in good condition with minor cracking of concrete base, # 2 rating.

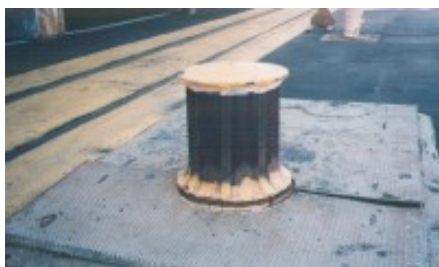
Photo 3.22-1, Dry Dock 8, fitting DD8S-CP2, capstan in good condition, # 1 rating.

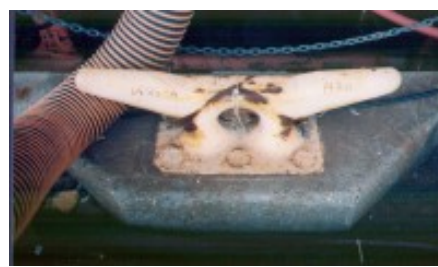
Photo 3.22-2, Dry Dock 8, fitting DD8S-C4, 42" type 3 cleat in good condition, # 2 rating.

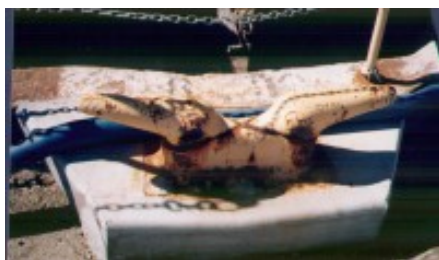
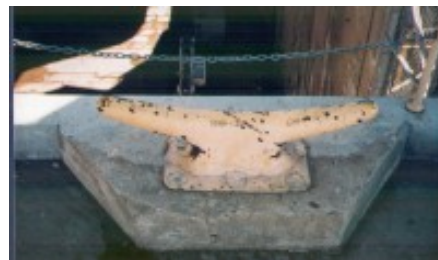
Photo 3.22-3, Dry Dock 8, fitting DD8S-C2, 42" type 1 cleat in good condition, # 1 rating.

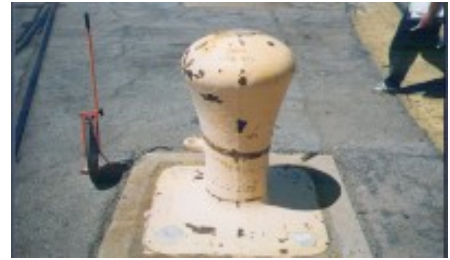
Photo 3.22-5, Dry Dock 8, fitting DD8S-B12, bollard with base paved over, # 1 rating.
